Manhole Inspection Summary

Manhole # S43M__025MH

Insp Date: **5/18/09 8:44 AM**

Location Address: **1641 LANCASTER ST**

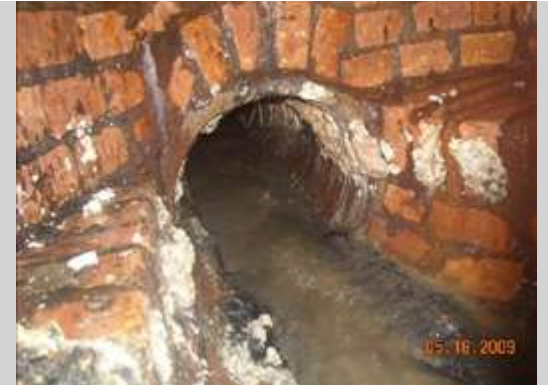
12 O'Clock Outflow

Pipe Height: **12** (in.) Rod and Bar (Angled)
Pipe Material: **Clay** ☐ Pipe Lined
Invert Depth: **15.00** (ft.) Flow Characteristics: **Slow**
Deposits: ☒ None ☐ Mud ☐ Sludge ☐ Debris ☐ Grease
Silt Depth: **0** (in.) Deposits Extent:
Infiltration: **None** Pipe Seal Cond: **Sound**
